**Flood Control Project Maintenance
Levee Inspections**

Fall 2018 Levee Maintenance Deficiency Summary Report

Sacramento River Basin

**Flood Control Project Maintenance
Levee Inspections****LMA District Cover Sheet****Fall 2018 Levee Inspection Results****Sutter Maintenance Yard Maintenance Area 0013**

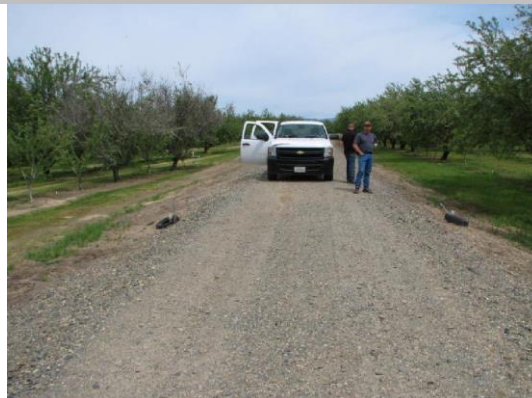
Photo 1 of 3 : UCIP_FA_2018_53313_66680.jpg

Overview of the crossing.

Comment Code						
Inspector Comment						
FS_ID:53313 DS_ID:16327 EP_NO: 6135 Repair Type: Urgent Crossing Status: Found UCIP Comments: 8/23/2018 Same as last inspection; crossing remains Urgent because levee erosion on both WS and LS still present (D. Sanoski - DWR UCIP).6/14/2017 LS slope still dug away from around the pipe. Appears no repairs have been made to the pipe yet. (DWR Sutter Yard- AFreitag)11/16/2016 Appears no repairs have been made here yet as LS slope is still dug away. (DWR Sutter Yard- AFreitag)4/28/2016 8-inch pipe was running water but was leaking at a weld joint on the LS slope. Pipe appears to have been dug out by the landowner but unsure if repairs are being made yet. (see photo 5)7/14/2015 Pipe end is still welded solid.5/21/2014 Same as last inspection.12/2/2013 Same as last inspection.7/10/2013 Same as last inspection. FIELD_STRUCT_DESC: 8-inch steel irrigation pipe through the levee 2.8 feet below the crown. Permit requirements are as follow: during the flood season the 5-inch irrigation pipe will be removed and a plate bolted over the waterside (WS) end of the 8-inch. Pipe section is completely buried. Current configuration does not allow for 5-inch irrigation pipe to slide pipe through. 8-inch pipe is welded solid. (Permit No. 6135, 1968 - George Washington) [Additional Reference(s): DWR Levee Log, 1993] FS Date: 8/23/2018 1:29:00 PM

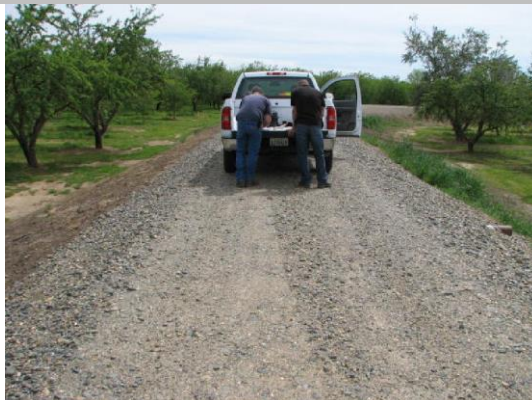
Photo 1 of 3 : UCIP_FA_2018_52179_66686.jpg

Comment Code						
Inspector Comment						
FS_ID:52179						
DS_ID:16342						
EP_NO: 12129						
Repair Type: Non-Urgent						
Crossing Status: Found						
UCIP Comments: 6/14/2017 Abandoned- needs to be done properly.						
(DWR Sutter Yard- AFreitag)11/16/2016 Abandoned. WS end still						
has plate bolted on. (DWR Sutter Yard- AFreitag)4/28/2016 Crossing						
still has plate bolted on it at the WS end and LS end was mostly						
buried.7/14/2015 WS pipe end still had plate bolted on it.5/21/2014						
Same as last inspection.12/2/2013 Same as last						
inspection.7/10/2013 Same as last inspection.4/12/2012 WS pipe						
daylight has bolted plate.						
FIELD_STRUCT_DESC: *ABANDONED* 6-inch steel irrigation pipe						
through the levee, 2.4 feet below the crown. Steel plate bolted on the						
waterside (WS) end. (Permit No. 12129, 12129A, 1977 - John & Jerie						
Malina) [Additional Reference(s): DWR Levee Log, 1993]

View of levee crown at crossing looking downstream at right bank of Cherokee Canal.

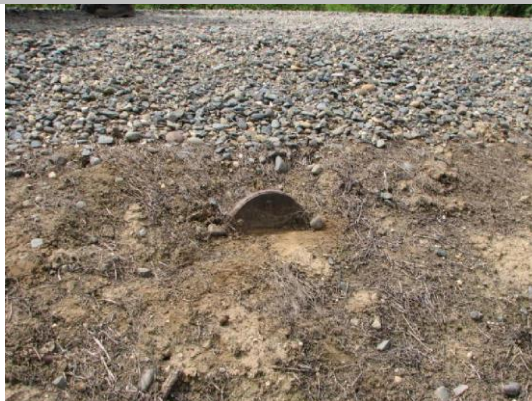
Photo 2 of 3 : UCIP_FA_2018_52179_66684.jpg

WS-Bolted plate

Comment Code						
Inspector Comment						
FS_ID:52179 DS_ID:16342 EP_NO: 12129 Repair Type: Non-Urgent Crossing Status: Found UCIP Comments: 6/14/2017 Abandoned- needs to be done properly. (DWR Sutter Yard- A Freitag)11/16/2016 Abandoned. WS end still has plate bolted on. (DWR Sutter Yard- A Freitag)4/28/2016 Crossing still has plate bolted on it at the WS end and LS end was mostly buried.7/14/2015 WS pipe end still had plate bolted on it.5/21/2014 Same as last inspection.12/2/2013 Same as last inspection.7/10/2013 Same as last inspection.4/12/2012 WS pipe daylight has bolted plate. FIELD_STRUCT_DESC: *ABANDONED* 6-inch steel irrigation pipe through the levee, 2.4 feet below the crown. Steel plate bolted on the waterside (WS) end. (Permit No. 12129, 12129A, 1977 - John & Jerie Malina) [Additional Reference(s): DWR Levee Log, 1993] FS Date: 6/16/2017 10:08:54 AM

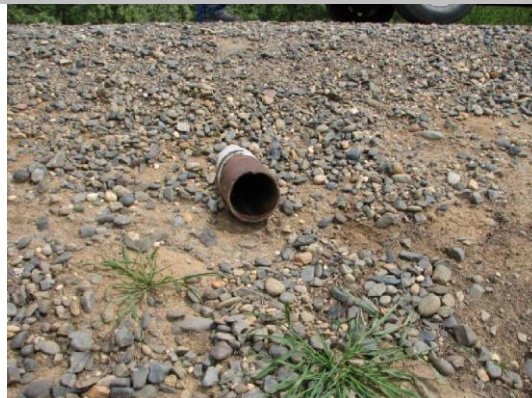
Photo 3 of 3 : UCIP_FA_2018_52179_66685.jpg

LS-Outlet

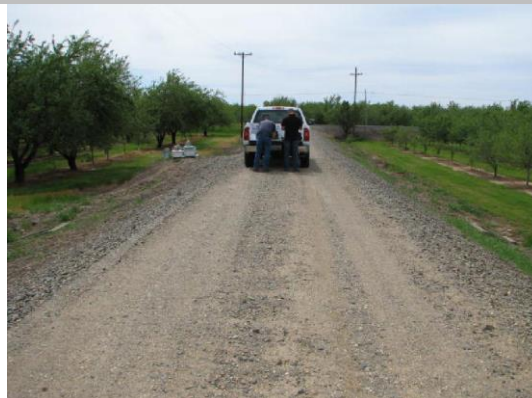
Photo 1 of 3 : UCIP_FA_2018_52180_66689.jpg

Comment Code					
Inspector Comment					
FS_ID:52180 DS_ID:16343 EP_NO: N/A Repair Type: No Action Needed Crossing Status: Found UCIP Comments: 6/14/2017 Crossing appears to be in good condition. Pipe has been selected to be internally cleaned and inspected as part of the DMP project. (DWR Sutter Yard- AFreitag)11/16/2016 Crossing appears to be in good condition. (DWR Sutter Yard- AFreitag)4/28/2016 Crossing appears to be in good condition.7/14/2015 Crossing appears in good condition. No noticeable issues to report.5/21/2014 Same as last inspection.12/2/2013 Same as last inspection.7/10/2013 Same as last inspection.4/17/2012 Drain is still in use. 4 inch pipe in channel near WS headwall (see photo). The pipe does not appear to impact the crossing. FIELD_STRUCT_DESC: 24-inch corrugated metal drainage pipe through the levee, 8.6 feet below the crown. Concrete "U" headwalls on both the waterside (WS) and landside (LS). Flap gate on the WS end. [Additional Reference(s): DWR Levee Log, 1993. USACE Sacramento O&M Manual 519, June 1962 (HLM 1.15)] FS Date: 6/16/2017 10:11:43 AM

Overview of levee crown at crossing looking D/S .

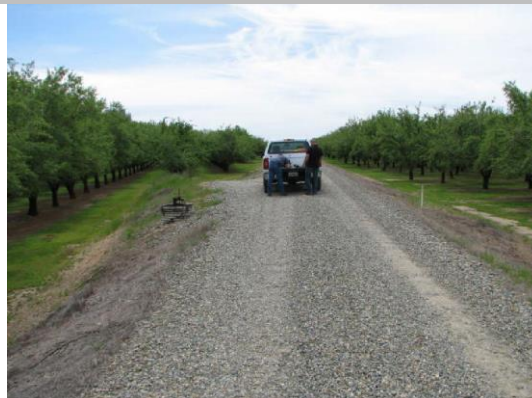
Photo 1 of 3 : UCIP_FA_2018_52183_66700.jpg

Comment Code						
Inspector Comment						
FS_ID:52183 DS_ID:16345 EP_NO: N/A Repair Type: Non-Urgent Crossing Status: Found UCIP Comments: 6/14/2017 PVC pipe still present blocking screw gate. LS inlet of the 24" cmp pipe is about 75% blocked by sediment. (DWR Sutter Yard- A/Freitag)11/16/2016 PVC pipe still present blocking the screw gate. (DWR Sutter Yard- A/Freitag)4/28/2016 Pvc pipe is still present through the crossing. Slide gate cannot shut fully.7/14/2015 4-inch pipe still present and blocking the screw gate.5/21/2014 Same as last inspection.12/2/2013 Same as last inspection.7/15/2013 Same as last inspection.4/17/2012 Crossing has 4-inch pipe inside blocking positive closure/notify landowner to remove prior to flood season. LS crossing is blocked about 50% by sediment build up. Burrow activity present on LS near crossing. FIELD_STRUCT_DESC: 24-inch corrugated metal irrigation pipe through the levee, 7.6 feet below the crown. Slide gate in corrugated metal pipe (CMP) riser on the waterside (WS) slope. Concrete headwall on the landside (LS). 36-inch concrete standpipe in the channel with 2 piles to deflect debris. [Additional Reference(s): DWR Levee Log, 1993. USACE Sacramento O&M Manual 519, June 1962 (HLM 1.69)] FS Date: 6/16/2017 12:21:04 PM

Overview of levee at crossing looking downstream.

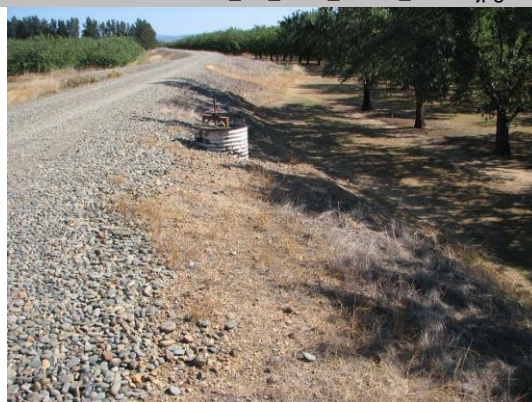
Photo 2 of 3 : UCIP_FA_2018_52183_66704.jpg

WS view looking upstream.

Comment Code						
Inspector Comment						
FS_ID:52183 DS_ID:16345 EP_NO: N/A Repair Type: Non-Urgent Crossing Status: Found UCIP Comments: 6/14/2017 PVC pipe still present blocking screw gate. LS inlet of the 24" cmp pipe is about 75% blocked by sediment. (DWR Sutter Yard- A Freitag)11/16/2016 PVC pipe still present blocking the screw gate. (DWR Sutter Yard- A Freitag)4/28/2016 Pvc pipe is still present through the crossing. Slide gate cannot shut fully.7/14/2015 4-inch pipe still present and blocking the screw gate.5/21/2014 Same as last inspection.12/2/2013 Same as last inspection.7/15/2013 Same as last inspection.4/17/2012 Crossing has 4-inch pipe inside blocking positive closure/notify landowner to remove prior to flood season. LS crossing is blocked about 50% by sediment build up. Burrow activity present on LS near crossing. FIELD_STRUCT_DESC: 24-inch corrugated metal irrigation pipe through the levee, 7.6 feet below the crown. Slide gate in corrugated metal pipe (CMP) riser on the waterside (WS) slope. Concrete headwall on the landside (LS). 36-inch concrete standpipe in the channel with 2 piles to deflect debris. [Additional Reference(s): DWR Levee Log, 1993. USACE Sacramento O&M Manual 519, June 1962 (HLM 1.69)] FS Date: 6/16/2017 12:21:04 PM

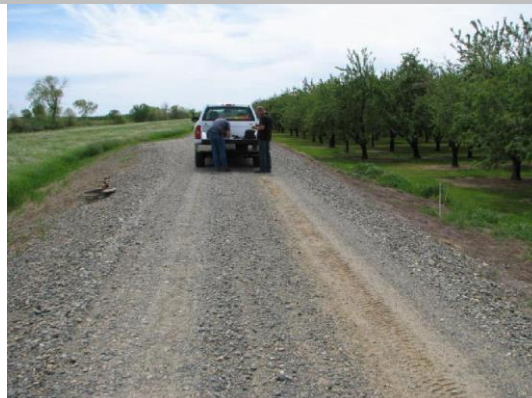
Photo 1 of 3 : UCIP_FA_2018_52184_66708.jpg

Comment Code						
Inspector Comment						
FS_ID:52184 DS_ID:16346 EP_NO: N/A Repair Type: Non-Urgent Crossing Status: Found UCIP Comments: 6/14/2017 Still no LS inlet visible- trace with locator/GPR to try and locate. Wooden debris down inside of WS standpipe. Pipe has been selected to be internally cleaned and inspected as part of the DMP project. (DWR Sutter Yard-AFreitag)11/16/2016 Appears abandoned. Unable to find anything on LS. (DWR Sutter Yard-AFreitag)4/28/2016 Appears to be an abandoned crossing. LS headwall and pipe inlet are still completely buried.7/14/2015 Still cannot find an inlet or outelt.5/21/2014 Same as last inspection.12/2/2013 Same as last inspection.7/15/2013 Same as last inspection.4/17/2012 Non functional crossing due to LS headwall buried. This crossing was listed in the USACE Periodic Inspection report as Corp's inspect ID#USACE_CESPK_M13D_2011_p_0119 for no inlet or outlet visible. FIELD_STRUCT_DESC: *ABANDONED* 24-inch corrugated metal irrigation pipe through the levee 7.8 feet below the crown. Slide gate in corrugated metal pipe riser on the waterside (WS) slope. Pipe continues across channel. Concrete "U" headwall on the landside (LS). [Additional Reference(s): DWR Levee Log, 1993. USACE Sacramento O&M Manual 519, June 1962 (HLM 2.35)] FS Date: 6/16/2017 12:24:07 PM

Overview of crossing looking DS.

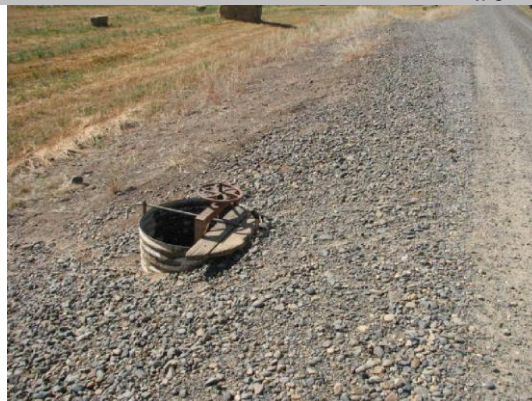
Photo 2 of 3 : UCIP_FA_2018_52184_66709.jpg

Corrugated riser located on WS slope.

Comment Code						
Inspector Comment						
FS_ID:52184 DS_ID:16346 EP_NO: N/A Repair Type: Non-Urgent Crossing Status: Found UCIP Comments: 6/14/2017 Still no LS inlet visible- trace with locator/GPR to try and locate. Wooden debris down inside of WS standpipe. Pipe has been selected to be internally cleaned and inspected as part of the DMP project. (DWR Sutter Yard-AFreitag)11/16/2016 Appears abandoned. Unable to find anything on LS. (DWR Sutter Yard-AFreitag)4/28/2016 Appears to be an abandoned crossing. LS headwall and pipe inlet are still completely buried.7/14/2015 Still cannot find an inlet or outelt.5/21/2014 Same as last inspection.12/2/2013 Same as last inspection.7/15/2013 Same as last inspection.4/17/2012 Non functional crossing due to LS headwall buried. This crossing was listed in the USACE Periodic Inspection report as Corp's inspect ID#USACE_CESPK_M13D_2011_p_0119 for no inlet or outlet visible. FIELD_STRUCT_DESC: *ABANDONED* 24-inch corrugated metal irrigation pipe through the levee 7.8 feet below the crown. Slide gate in corrugated metal pipe riser on the waterside (WS) slope. Pipe continues across channel. Concrete "U" headwall on the landside (LS). [Additional Reference(s): DWR Levee Log, 1993. USACE Sacramento O&M Manual 519, June 1962 (HLM 2.35)] FS Date: 6/16/2017 12:24:07 PM

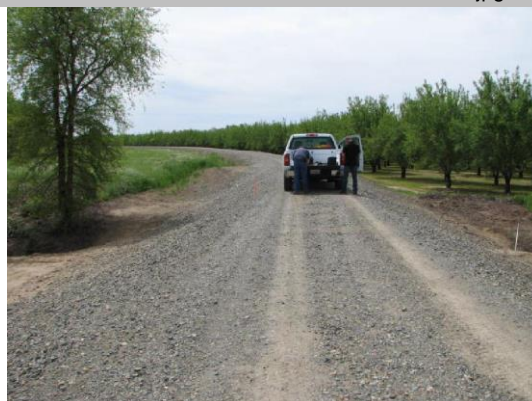
Photo 1 of 3 : UCIP_FA_2018_52185_66715.jpg

Comment Code					
Inspector Comment					
FS_ID:52185 DS_ID:16347 EP_NO: N/A Repair Type: No Action Needed Crossing Status: Found UCIP Comments: 6/14/2017 Crossing appears to be in good condition. (DWR Sutter Yard- A Freitag)11/16/2016 Crossing appears to be in good condition. (DWR Sutter Yard- A Freitag)4/28/2016 Crossing appears to be in good condition.7/14/2015 Crossing appears in good condition. No noticeable issues to report.5/21/2014 Same as last inspection.12/2/2013 Same as last inspection.7/15/2013 Same as last inspection.4/17/2012 Vegetation/sedimentation from WS has been removed. This crossing was listed in the USACE Periodic Inspection report as Corp's inspect ID#USACE_CESPK_M13D_2011_p_0130 for WS flap gate closed and blocked by sediment. FIELD_STRUCT_DESC: 24-inch corrugated metal drainage pipe through the levee, 9.4 feet below the crown. Concrete "U" headwall on both waterside (WS) and landside (LS) ends. Flap gate on the WS end. [Additional Reference(s): DWR Levee Log, 1993. USACE Sacramento O&M Manual 519, June 1962 (HLM 2.74)] FS Date: 6/16/2017 12:27:02 PM

Overview of levee crown looking downstream at crossing.

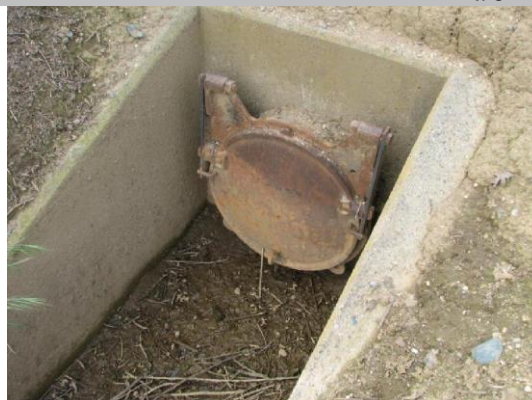
Photo 2 of 3 : UCIP_FA_2018_52185_66714.jpg

Flap gate at WS.

Comment Code						
Inspector Comment						
FS_ID:52185 DS_ID:16347 EP_NO: N/A Repair Type: No Action Needed Crossing Status: Found UCIP Comments: 6/14/2017 Crossing appears to be in good condition. (DWR Sutter Yard- AFreitag)11/16/2016 Crossing appears to be in good condition. (DWR Sutter Yard- AFreitag)4/28/2016 Crossing appears to be in good condition.7/14/2015 Crossing appears in good condition. No noticeable issues to report.5/21/2014 Same as last inspection.12/2/2013 Same as last inspection.7/15/2013 Same as last inspection.4/17/2012 Vegetation/sedimentation from WS has been removed. This crossing was listed in the USACE Periodic Inspection report as Corp's inspect ID#USACE_CESPK_M13D_2011_p_0130 for WS flap gate closed and blocked by sediment. FIELD_STRUCT_DESC: 24-inch corrugated metal drainage pipe through the levee, 9.4 feet below the crown. Concrete "U" headwall on both waterside (WS) and landside (LS) ends. Flap gate on the WS end. [Additional Reference(s): DWR Levee Log, 1993. USACE Sacramento O&M Manual 519, June 1962 (HLM 2.74)] FS Date: 6/16/2017 12:27:02 PM

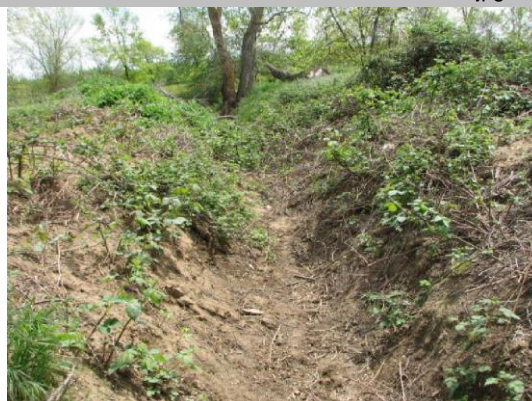
Photo 3 of 3 : UCIP_FA_2018_52185_66711.jpg

View of channel.

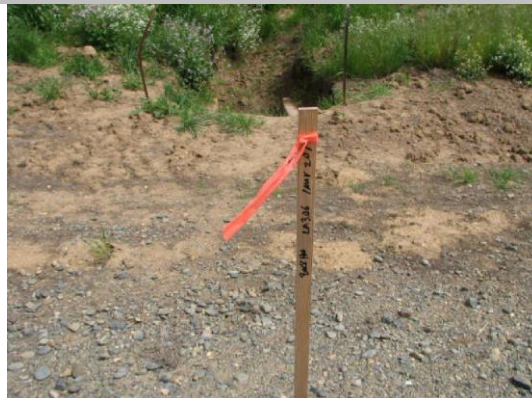
Photo 2 of 3 : UCIP_FA_2018_52186_66716.jpg

Comment Code						
Inspector Comment						
FS_ID:52186 DS_ID:17372 EP_NO: N/A Repair Type: Non-Urgent Crossing Status: Found UCIP Comments: 6/14/2017 WS flap gate is completely buried by sediment- needs to be dug out. Pipe is about 50% full of sediment inside. Pipe has been selected to be internally cleaned and inspected as part of the DMP project. (DWR Sutter Yard- AFreitag)11/16/2016 Pipe about 50% full of sediment. (DWR Sutter Yard- AFreitag)4/28/2016 Pipe on LS is about 50% full of sediment. There is now a concrete pipe that discharges into the LS inlet of this crossing. Not sure where the concrete pipe comes from.7/14/2015 Crossing appears in good condition. No noticeable issues to report.5/21/2014 Same as last inspection.12/2/2013 Pipe section was dug up and repaired. Crossing is now in good condition.7/15/2013 Pipe appears to have a possible hole in top of pipe about 10ft. in from LS headwall.4/17/2012 LS headwall blocked by sediment (50 % of opening is covered). LS floor is higher than LS pipe invert. WS headwall has been recently cleared of vegetation and sediment. This crossing was listed in the USACE Periodic Inspection report as Corp's inspect ID#USACE_CESPK_M13D_2011_p_0157 for WS and LS inlet/outlet blocked by sediment. FIELD_STRUCT_DESC: 36-inch corrugated metal drainage pipe through the levee, 11.8 feet below the crown. Flap gate is located on the waterside (WS). Concrete headwall located on the landside (LS). [Additional Reference(s): USACE Sacramento O&M Manual 519, June 1962 (HLM 3.10)] FS Date: 6/16/2017 12:28:31 PM

WS levee slope.

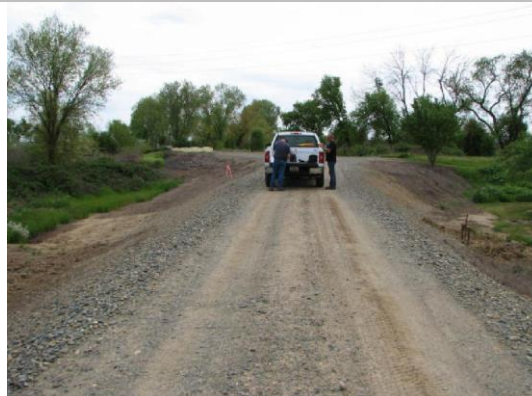
Photo 1 of 3 : UCIP_FA_2018_52188_66725.jpg

Overview of levee crown looking DS at crossing.

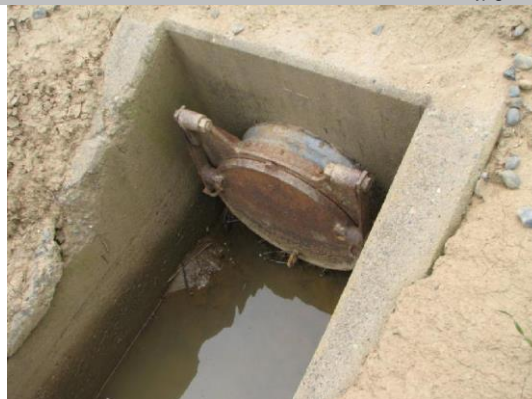
Photo 2 of 3 : UCIP_FA_2018_52188_66724.jpg

Flap gate on WS.

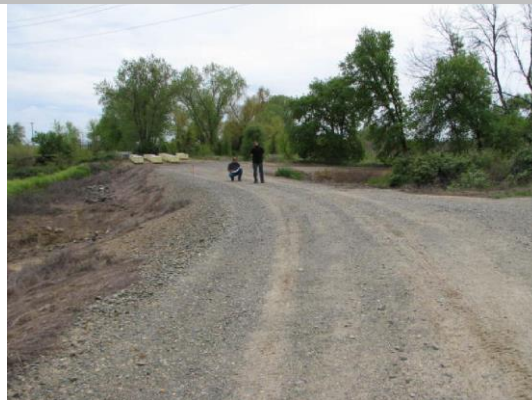
Photo 1 of 3 : UCIP_FA_2018_52189_66731.jpg

Overview of levee crown at crossing.

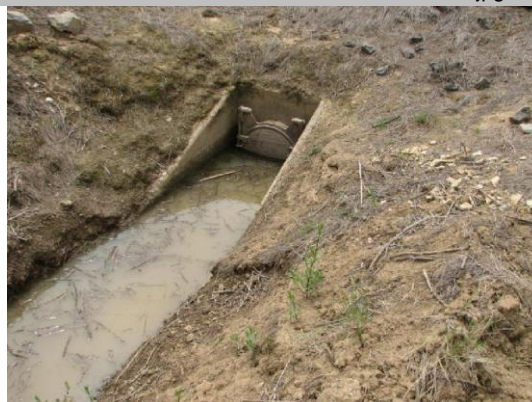
Photo 2 of 3 : UCIP_FA_2018_52189_66730.jpg

View of WS flap gate.

Comment Code					
Inspector Comment					
FS_ID:52189 DS_ID:16350 EP_NO: N/A Repair Type: No Action Needed Crossing Status: Found UCIP Comments: 6/14/2017 WS flapgate is buried by sediment- needs to be dug out. Pipe has been selected to be internally cleaned and inspected as part of the DMP project. (DWR Sutter Yard- A/Freitag)11/16/2016 Crossing appears to be in good condition. (DWR Sutter Yard- A/Freitag)4/28/2016 Crossing appears to be in good condition.7/14/2015 Crossing appears in good condition. No noticeable issues to report.5/21/2014 Same as last inspection.12/2/2013 Same as last inspection.7/15/2013 Same as last inspection.4/17/2012 WS headwall has been cleared of debris and sedimentation. FIELD_STRUCT_DESC: 24-inch corrugated metal drainage pipe through the levee, 8.4 feet below the crown. Concrete "U" headwalls on both the waterside (WS) and landside (LS) ends. Flap gate on the WS end. [Additional Reference(s): DWR Levee Log, 1993. USACE Sacramento O&M Manual 519, June 1962 (HLM 3.31)] FS Date: 6/16/2017 12:32:19 PM

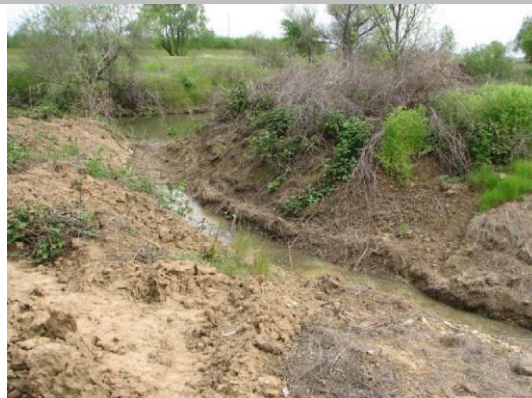
Photo 3 of 3 : UCIP_FA_2018_52189_66732.jpg

Sedimentation cleared on WS.

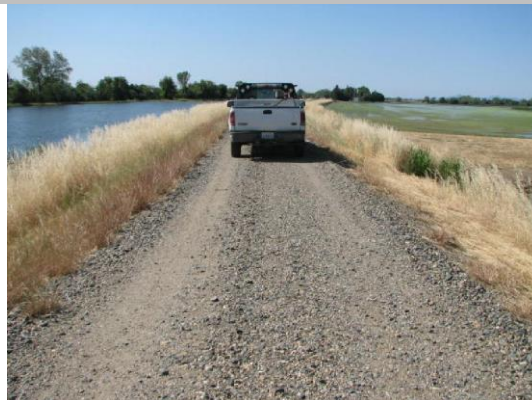
Photo 1 of 3 : UCIP_FA_2018_52190_66736.jpg

Overview of levee crown at crossing looking downstream.

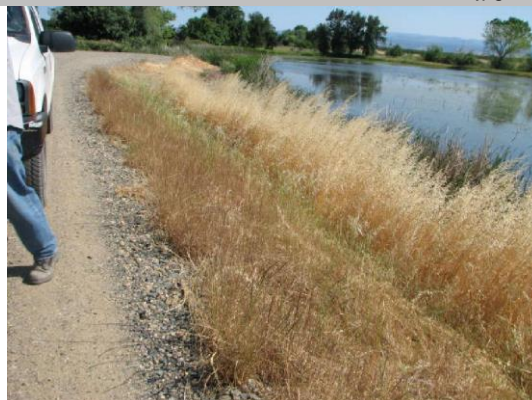
Photo 2 of 3 : UCIP_FA_2018_52190_66738.jpg

WS slope covered by dense vegetation.

Item	DWR UCIP LMA Responsibility			39.546592 °	39.546592 °	
				-121.707560 °	-121.707560 °	
DWR ID	16351					
Comment Code						
Inspector Comment						
FS_ID:52190 DS_ID:16351 EP_NO: N/A Repair Type: No Action Needed Crossing Status: Found UCIP Comments: 6/14/2017 Both pipe ends were underwater during site visit. Pipe has been selected to be internally cleaned and inspected as part of the DMP project. (DWR Sutter Yard- A Freitag)11/16/2016 Crossing appears to be in good condition. (DWR Sutter Yard- A Freitag)4/28/2016 Both sides of the crossing were underwater during time of inspection.7/14/2015 Crossing appears in good condition. No noticeable issues to report.5/21/2014 Same as last inspection.12/2/2013 Same as last inspection.7/15/2013 Slopes have been cleared of vegetation and are in good condition.4/18/2012 Limited inspection on WS and LS slope due to dense vegetation. Need photos of cleared slopes. FIELD_STRUCT_DESC: 24-inch corrugate metal drainage pipe through the levee, 8.1 feet below the crown. Flap gate on the waterside (WS) end. Slide gate located on the landside (LS) end. Concrete "U" headwalls on both ends. [Additional Reference(s): DWR Levee Log, 1993. USACE Sacramento O&M Manual 519, June 1962 (HLM 3.80)] FS Date: 6/16/2017 12:33:16 PM

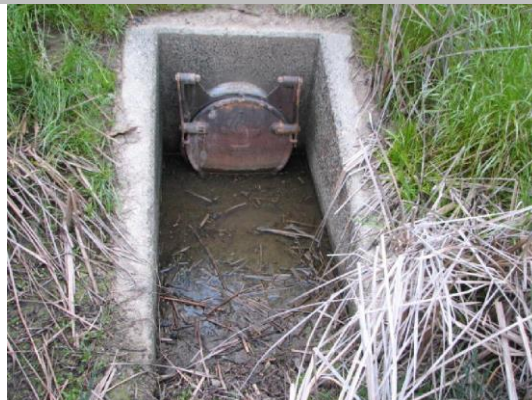
Photo 3 of 3 : UCIP_FA_2018_52190_66735.jpg

WS flap gate

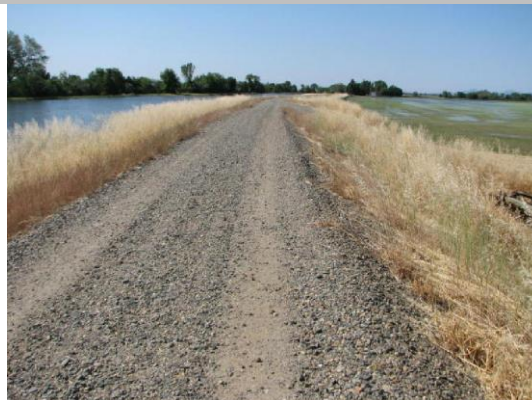
Photo 1 of 3 : UCIP_FA_2018_52191_66743.jpg

Overview of levee crown at crossing looking downstream.

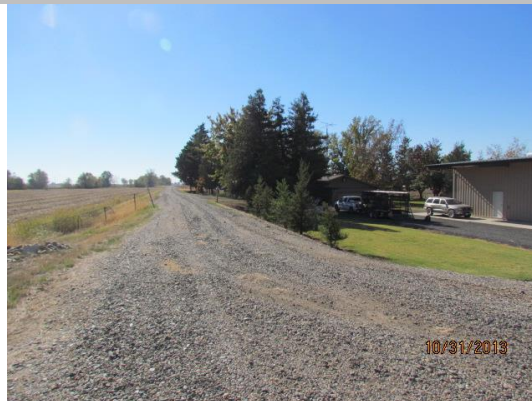
Photo 1 of 1 : FA_2018_MA0013_300_18_20180905_00005.jpg

LM Start	4.06	Rating **	M	Issue No.	18
LM End	4.13	Issue Type +	En	Location *	LS
Category	Earthen Levee			GPS Latitude/Longitude	
				Start	End
Item	Vegetation			39.541660 °	39.540651 °
				-121.707408 °	-121.707404 °
DWR ID	DWR_MA0013_01_s_2013_18				
Comment Code					
V6 : Landscaping					
Inspector Comment

View of the redwood trees along the landside slope.

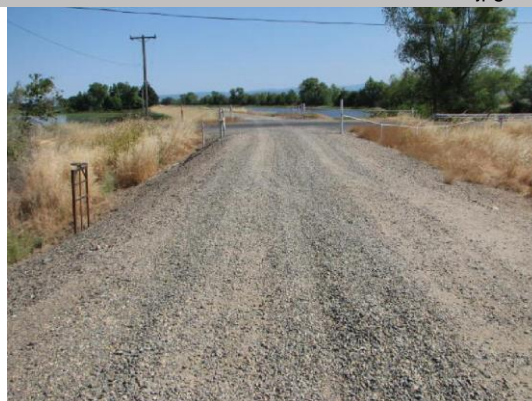
Photo 1 of 3 : UCIP_FA_2018_52193_66752.jpg

Overview of levee crown at crossing looking upstream.

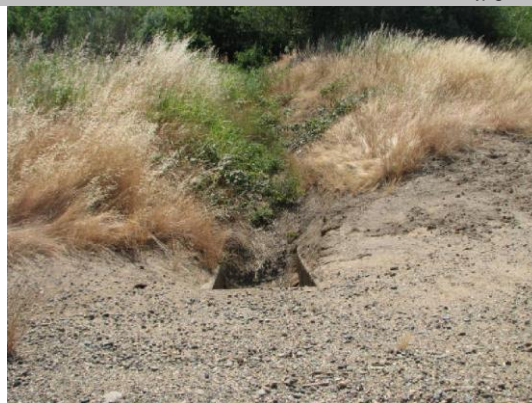
Photo 2 of 3 : UCIP_FA_2018_52193_66753.jpg

View of WS slope and toe.

Comment Code					
Inspector Comment					
FS_ID:52193 DS_ID:16341 EP_NO: N/A Repair Type: No Action Needed Crossing Status: Found UCIP Comments: 6/14/2017 WS flapgate is shut but blocked by sediment- needs to be dug out. LS slide gate has some minor sediment built up against it. Pipe has been selected to be internally cleaned and inspected as part of the DMP project. (DWR Sutter Yard-AFreitag)11/16/2016 Crossing appears to be in good condition. (DWR Sutter Yard- AFreitag)4/28/2016 Crossing appears to be in good condition.7/13/2015 Crossing appears in good condition. No noticeable issues to report.5/21/2014 Same as last inspection.12/2/2013 Same as last inspection.7/15/2013 Same as last inspection.4/18/2012 Minor debris on landside inlet. This crossing was listed in the USACE Periodic Inspection report as Corp's inspect ID#USACE_CESPK_M13D_2011_p_0189 for sediment and grass blocking WS and LS. FIELD_STRUCT_DESC: 36-inch corrugated metal drainage pipe through the levee, 9.1 feet below the crown. Flap gate on the waterside (WS) end. Slide gate located on the landside (LS) end. Concrete "U" headwalls on both ends. [Additional Reference(s): DWR Levee Log, 1993. USACE Sacramento O&M Manual 519, June 1962 (HLM 4.43)] FS Date: 6/16/2017 12:52:19 PM

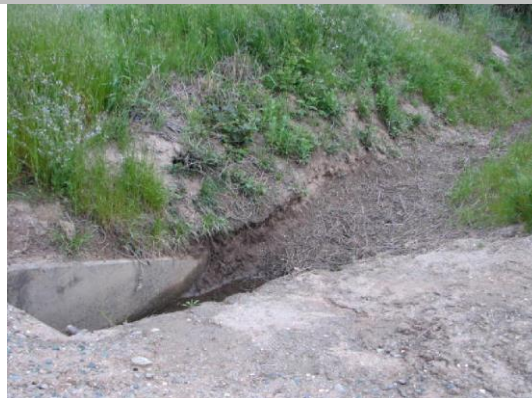
Photo 3 of 3 : UCIP_FA_2018_52193_66750.jpg

View of WS.

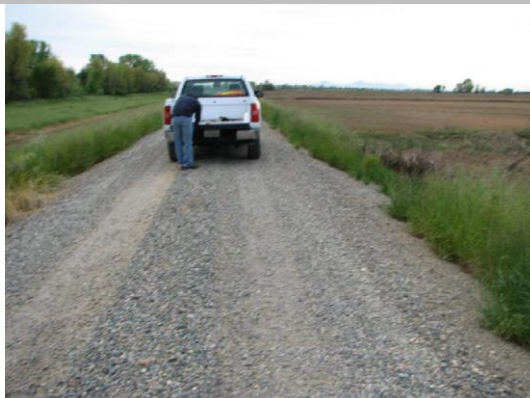
Photo 1 of 3 : UCIP_FA_2018_52194_66756.jpg

Overview of levee crown at crossing looking downstream at right bank of Cherokee Canal.

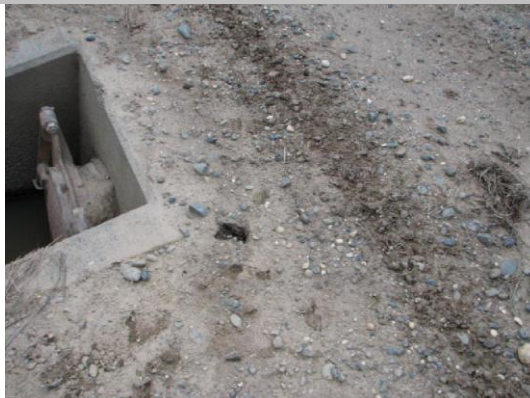
Photo 2 of 3 : UCIP_FA_2018_52194_66758.jpg

Burrow activity on WS slope.

Item	DWR UCIP LMA Responsibility			39.530220°		39.530220°
				-121.707940°		-121.707940°
DWR ID	16355					
Comment Code						
Inspector Comment						
FS_ID:52194 DS_ID:16355 EP_NO: N/A Repair Type: No Action Needed Crossing Status: Found UCIP Comments: 6/14/2017 WS flapgate is submerged and appears to be half buried by sediment. LS slide gate is fully submerged on the edge of the rice field. Pipe has been selected to be internally cleaned and inspected as part of the DMP project. (DWR Sutter Yard- AFreitag)11/16/2016 Crossing appears to be in good condition. (DWR Sutter Yard- AFreitag)4/28/2016 Crossing appears to be in good condition.7/13/2015 LS screw gate was completely submerged but crossing appears to be in good condition.5/21/2014 Same as last inspection.12/2/2013 Same as last inspection.7/15/2013 No signs of burrowing activity on this inspection.4/18/2012 Burrow activity near crossing, burrow holes present on WS slope. FIELD_STRUCT_DESC: 24-inch corrugated metal drainage pipe through the levee 7.7 feet below the crown. Flap gate on the waterside (WS) end. Slide gate located on the landside (LS) end. Concrete "U" headwalls on both ends. [Additional Reference(s): DWR Levee Log, 1993. USACE Sacramento O&M Manual 519, June 1962 (HLM 4.94)] FS Date: 6/16/2017 12:55:37 PM

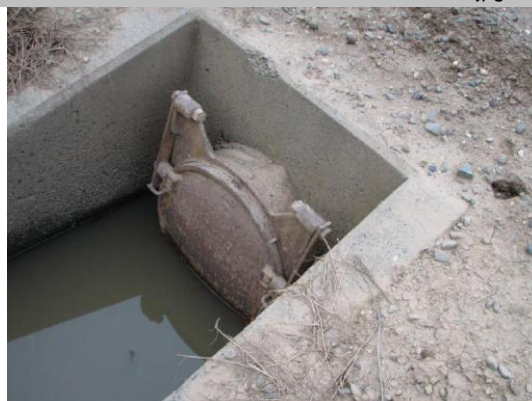
Photo 3 of 3 : UCIP_FA_2018_52194_66755.jpg

View of WS flap gate.

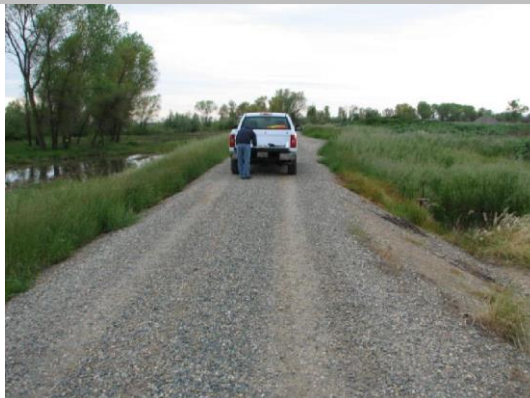
Photo 1 of 3 : UCIP_FA_2018_52195_66762.jpg

Overview of levee crown at crossing looking D/S on right bank of Cherokee Canal.

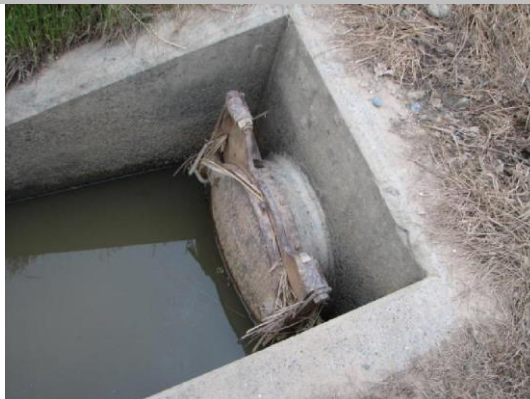
Photo 2 of 3 : UCIP_FA_2018_52195_66760.jpg

FS_ID:52195
DS_ID:16356
EP_NO: N/A
Repair Type: No Action Needed
Crossing Status: Found
UCIP Comments: 6/14/2017 Crossing appears to be in good conditio. Pipe has been selected to be internally cleaned and inspected as part of the DMP project. (DWR Sutter Yard- A Freitag) 11/16/2016 Crossing appears to be in good condition. (DWR Sutter Yard- A Freitag) 4/28/2016 Crossing appears to be in good condition. 7/13/2015 LS screw gate was completely submerged and WS flapgate was propped open by a wood block but crossing appears to be in good condition. 5/21/2014 Same as last inspection. 12/2/2013 Same as last inspection. 7/15/2013 Same as last inspection. 4/18/2012 Minor vegetation on LS slope. This crossing was listed in the USACE Periodic Inspection report as Corp's inspect ID#USACE_CESPK_M13D_2011_p_0204 for restriction view of gates. FIELD_STRUCT_DESC: 24-inch corrugated metal drainage pipe through the levee, 8.4 feet below the crown. Flap gate on the waterside (WS) end. Slide gate on the landside (LS) end. Concrete "U" headwalls on both ends. [Additional Reference(s): DWR Levee Log, 1993. USACE Sacramento O&M Manual 519, June 1962 (HLM 5.43)]

WS Flap Gate

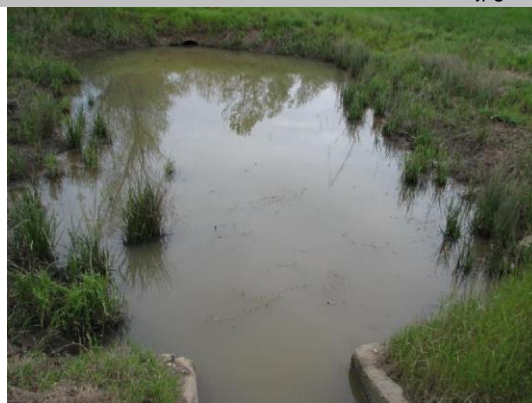
Photo 3 of 3 : UCIP_FA_2018_52195_66763.jpg

Item	DWR UCIP LMA Responsibility			39.523236 °		39.523236 °
				-121.707650 °		-121.707650 °
DWR ID	16356					
Comment Code						
Inspector Comment						
FS_ID:52195 DS_ID:16356 EP_NO: N/A Repair Type: No Action Needed Crossing Status: Found UCIP Comments: 6/14/2017 Crossing appears to be in good conditio. Pipe has been selected to be internally cleaned and inspected as part of the DMP project. (DWR Sutter Yard- A Freitag)11/16/2016 Crossing appears to be in good condition. (DWR Sutter Yard- A Freitag)4/28/2016 Crossing appears to be in good condition.7/13/2015 LS screw gate was completely submerged and WS flapgate was propped open by a wood block but crossing appears to be in good condition.5/21/2014 Same as last inspection.12/2/2013 Same as last inspection.7/15/2013 Same as last inspection.4/18/2012 Minor vegetation on LS slope. This crossing was listed in the USACE Periodic Inspection report as Corp's inspect ID#USACE_CESPK_M13D_2011_p_0204 for restriction view of gates. FIELD_STRUCT_DESC: 24-inch corrugated metal drainage pipe through the levee, 8.4 feet below the crown. Flap gate on the waterside (WS) end. Slide gate on the landside (LS) end. Concrete "U" headwalls on both ends. [Additional Reference(s): DWR Levee Log, 1993. USACE Sacramento O&M Manual 519, June 1962 (HLM 5.43)] FS Date: 6/16/2017 1:04:28 PM

WS view of outlet cleared of vegetation.

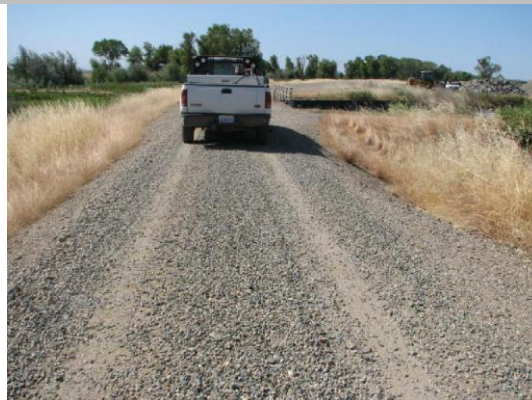
Photo 1 of 3 : UCIP_FA_2018_52196_66764.jpg

FS_ID:52196
DS_ID:16357
EP_NO: N/A
Repair Type: Non-Urgent
Crossing Status: Found
UCIP Comments: 6/14/2017 WS flapgate is partially buried by sediment- needs to be dug out. LS appears to be in good condition. Pipe has been selected to be internally cleaned and inspected as part of the DMP project. (DWR Sutter Yard- AFreitag)11/16/2016 WS flap gate closed but blocked from opening by sediment. (DWR Sutter Yard- AFreitag)4/28/2016 WS flap gate blocked from opening by sediment.7/13/2015 WS flap gate is blocked from opening by sediment. Needs to be dug out.5/21/2014 Same as last inspection.12/2/2013 Same as last inspection.7/15/2013 Slopes have been cleared of vegetation and are in good condition.4/18/2012 Limited inspection on WS and LS slopes due to dense vegetation. Need photos of cleared slopes.
FIELD_STRUCT_DESC: 24-inch corrugated metal drainage pipe through the levee, 8.6 feet below the crown. Flap gate on the waterside (WS) end. Concrete "U" headwalls an both ends. [Additional Reference(s): DWR Levee Log, 1993. USACE Sacramento O&M Manual 519, June 1962 (HLM 5.48)]

Overview of levee crown at crossing looking downstream.

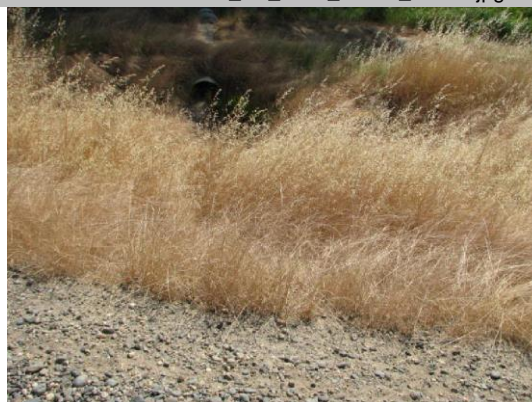
Photo 2 of 3 : UCIP_FA_2018_52196_66765.jpg

View of WS slope and channel.

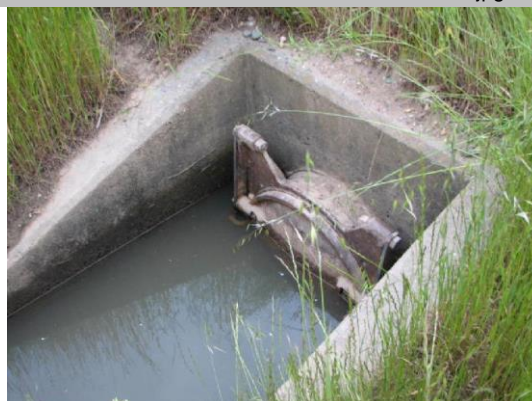
Photo 3 of 3 : UCIP_FA_2018_52196_66768.jpg

Comment Code						
Inspector Comment						
FS_ID:52196						
DS_ID:16357						
EP_NO: N/A						
Repair Type: Non-Urgent						
Crossing Status: Found						
UCIP Comments: 6/14/2017 WS flapgate is partially buried by sediment- needs to be dug out. LS appears to be in good condition. Pipe has been selected to be internally cleaned and inspected as part of the DMP project. (DWR Sutter Yard- AFreitag)11/16/2016 WS flap gate closed but blocked from opening by sediment. (DWR Sutter Yard- AFreitag)4/28/2016 WS flap gate blocked from opening by sediment.7/13/2015 WS flap gate is blocked from opening by sediment. Needs to be dug out.5/21/2014 Same as last inspection.12/2/2013 Same as last inspection.7/15/2013 Slopes have been cleared of vegetation and are in good condition.4/18/2012 Limited inspection on WS and LS slopes due to dense vegetation. Need photos of cleared slopes.						
FIELD_STRUCT_DESC: 24-inch corrugated metal drainage pipe through the levee, 8.6 feet below the crown. Flap gate on the waterside (WS) end. Concrete "U" headwalls an both ends. [Additional Reference(s): DWR Levee Log, 1993. USACE Sacramento O&M Manual 519, June 1962 (HLM 5.48)]

View of WS flap gate.

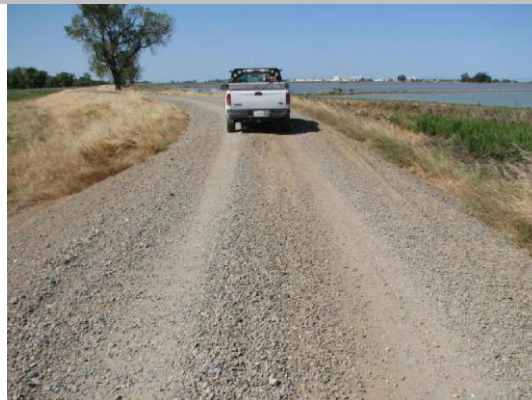
Photo 1 of 3 : UCIP_FA_2018_52201_66793.jpg

FS_ID:52201
DS_ID:16359
EP_NO: N/A
Repair Type: Non-Urgent
Crossing Status: Found
UCIP Comments: 6/14/2017 WS Flap gate is completely buried- needs to be dug out. LS is blocked off by flashboards that are partially buried. Pipe has been selected to be internally cleaned and inspected as part of the DMP project. (DWR Sutter Yard- A Freitag)11/16/2016 WS still completely buried. (DWR Sutter Yard- A Freitag)4/28/2016 WS gate and headwall are buried. Only the top of the headwall was visible. LS appeared ok.7/13/2015 Both the LS screw gate and WS flapgate are completely buried.5/21/2014 Same as last inspection.12/2/2013 Same as last inspection.7/15/2013 Slopes have been cleared of vegetation and are in good condition. WS headwall and flapgate are fully covered in debris and not visible. Need to clear.4/18/2012 High sedimentation build up at WS and LS headwall. Limited inspection due to dense vegetation on WS and LS slope. Need photo of cleared WS and LS slopes. This crossing was listed in the USACE Periodic Inspection report as Corp's inspect ID# USACE_CESPK_M13D_2011_p_0210 for WS gate submerged. FIELD_STRUCT_DESC: 24-inch corrugated metal drainage pipe through the levee, 9.2 feet below the crown. Flap gate on the waterside (WS) end. Concrete "U" headwalls on both ends. [Additional Reference(s): DWR Levee Log, 1993. USACE Sacramento O&M Manual 519, June 1962 (HLM 5.73)]

Overview of levee crown at crossing looking downstream.

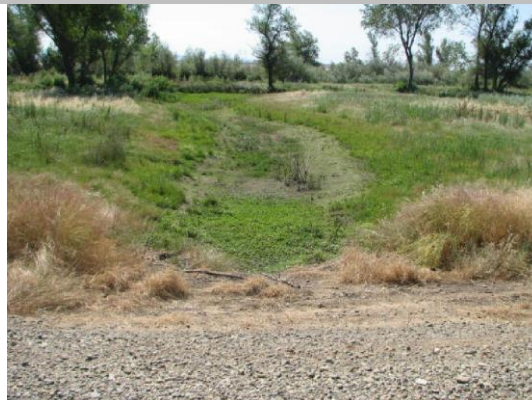
Photo 2 of 3 : UCIP_FA_2018_52201_66794.jpg

View of WS slope and toe.

Comment Code						
Inspector Comment						
FS_ID:52201 DS_ID:16359 EP_NO: N/A Repair Type: Non-Urgent Crossing Status: Found UCIP Comments: 6/14/2017 WS Flap gate is completely buried- needs to be dug out. LS is blocked off by flashboards that are partially buried. Pipe has been selected to be internally cleaned and inspected as part of the DMP project. (DWR Sutter Yard- AFreitag)11/16/2016 WS still completely buried. (DWR Sutter Yard- AFreitag)4/28/2016 WS gate and headwall are buried. Only the top of the headwall was visible. LS appeared ok.7/13/2015 Both the LS screw gate and WS flapgate are completely buried.5/21/2014 Same as last inspection.12/2/2013 Same as last inspection.7/15/2013 Slopes have been cleared of vegetation and are in good condition. WS headwall and flapgate are fully covered in debris and not visible. Need to clear.4/18/2012 High sedimentation build up at WS and LS headwall. Limited inspection due to dense vegetation on WS and LS slope. Need photo of cleared WS and LS slopes. This crossing was listed in the USACE Periodic Inspection report as Corp's inspect ID# USACE_CESPK_M13D_2011_p_0210 for WS gate submerged. FIELD_STRUCT_DESC: 24-inch corrugated metal drainage pipe through the levee, 9.2 feet below the crown. Flap gate on the waterside (WS) end. Concrete "U" headwalls on both ends. [Additional Reference(s): DWR Levee Log, 1993. USACE Sacramento O&M Manual 519, June 1962 (HLM 5.73)] FS Date: 6/16/2017 1:29:37 PM

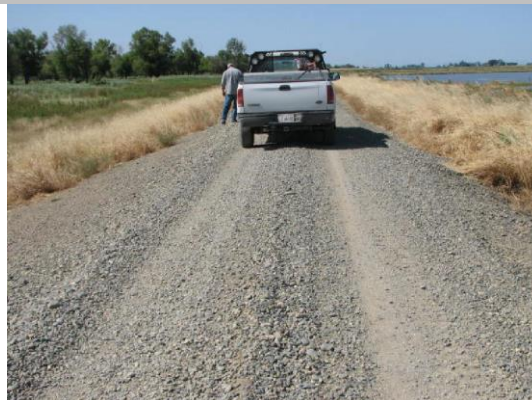
Photo 1 of 3 : UCIP_FA_2018_52202_66800.jpg

Comment Code						
Inspector Comment						
FS_ID:52202						
DS_ID:16360						
EP_NO: N/A						
Repair Type: No Action Needed						
Crossing Status: Found						
UCIP Comments: 6/14/2017 Crossing appears to be in good condition.						
LS is completely submerged in an irrigation ditch. Pipe has been						
selected to be internally cleaned and inspected as part of the DMP						
project. (DWR Sutter Yard- A Freitag)11/16/2016 Crossing appears to						
be in good condition. (DWR Sutter Yard- A Freitag)4/28/2016						
Crossing appears to be in good condition.7/13/2015 LS screw gate						
was completely submerged but crossing appears to be in good						
condition.5/21/2014 Same as last inspection.12/2/2013 Same as						
last inspection.7/15/2013 Same as last inspection.4/18/2012						
Burrow activity near crossing; burrow holes present on LS.						
FIELD_STRUCT_DESC: 24-inch corrugated metal drainage pipe						
through the levee, 6.2 feet below the crown. Flap gate on the waterside

Overview of levee crown at crossing looking downstream.

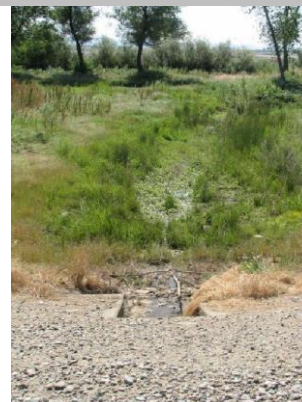
Photo 2 of 3 : UCIP_FA_2018_52202_66801.jpg

View of WS slope and toe.

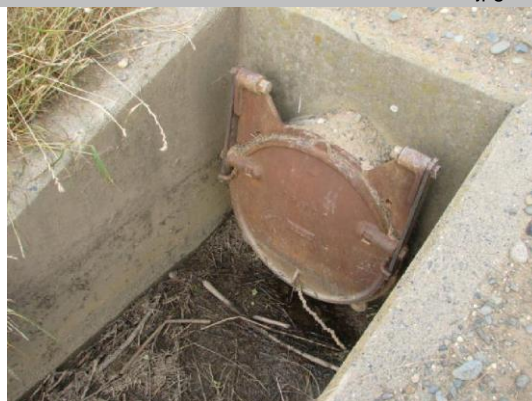
Photo 3 of 3 : UCIP_FA_2018_52202_66799.jpg

Item	DWR UCIP LMA Responsibility			39.516059 °	39.516059 °	
				-121.710810 °	-121.710810 °	
DWR ID	16360					
Comment Code						
Inspector Comment						
FS_ID:52202						
DS_ID:16360						
EP_NO: N/A						
Repair Type: No Action Needed						
Crossing Status: Found						
UCIP Comments: 6/14/2017 Crossing appears to be in good condition.						
LS is completely submerged in an irrigation ditch. Pipe has been						
selected to be internally cleaned and inspected as part of the DMP						
project. (DWR Sutter Yard- A/Freitag)11/16/2016 Crossing appears to						
be in good condition. (DWR Sutter Yard- A/Freitag)4/28/2016						
Crossing appears to be in good condition.7/13/2015 LS screw gate						
was completely submerged but crossing appears to be in good						
condition.5/21/2014 Same as last inspection.12/2/2013 Same as						
last inspection.7/15/2013 Same as last inspection.4/18/2012						
Burrow activity near crossing; burrow holes present on LS.

Flap gate WS

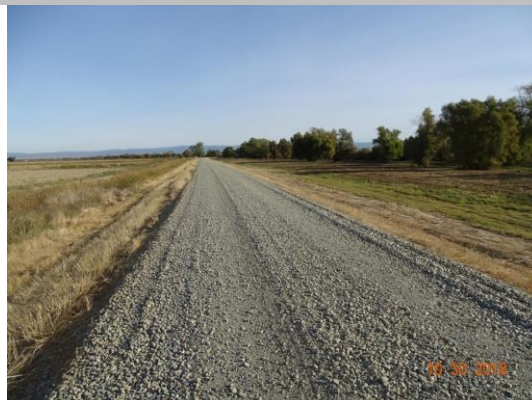
Photo 1 of 1 : FA_2018_MA0013_300_55_20181102_00141.jpg

LM Start	6.03	Rating **	A	Issue No.	55	
LM End	6.03	Issue Type +	Ma	Location *	LS	
Category	Earthen Levee			GPS Latitude/Longitude		
				Start		End
Item	Vegetation			39.514018 °		39.514018 °
				-121.712027 °		-121.712027 °
DWR ID	DWR_MA0013_01_f_2018_55					
Comment Code						
V1 : Control annual grass and weeds on the levee slopes and easements.						
Inspector Comment						
The vegetation was mowed on both slopes.

View of the mowed vegetation on both slopes.

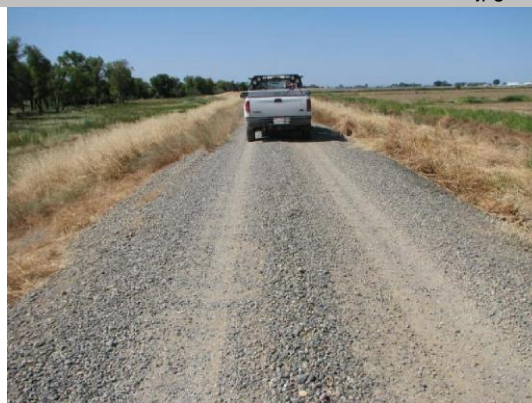
Photo 1 of 3 : UCIP_FA_2018_52203_66808.jpg

Comment Code						
Inspector Comment						
FS_ID:52203 DS_ID:16361 EP_NO: N/A Repair Type: Non-Urgent Crossing Status: Found UCIP Comments: 6/14/2017 WS appears to be in good condition. LS slide gate is buried and submerged. Pipe has been selected to be internally cleaned and inspected as part of the DMP project. (DWR Sutter Yard- AFreitag)11/16/2016 LS screwgate is buried and non-operational. (DWR Sutter Yard- AFreitag)4/28/2016 LS screwgate is still completely buried. 7/13/2015 LS screw gate is completely buried.5/21/2014 Same as last inspection.7/15/2013 WS slope has been cleared of vegetation and is in good condition. LS screw gate is still buried.12/2/2013 Same as last inspection.4/18/2012 LS slide gate is buried. Pipe is not visible on LS toe. Limited inspection on WS slope due to dense vegetation. FIELD_STRUCT_DESC: 24-inch corrugated metal drainage pipe through the levee, 7.4 feet below the crown. Flap gate on the waterside (WS) end. Slide gate on the landside (LS) end. Concrete "U" headwalls on both ends. [Additional Reference(s): DWR Levee Log, 1993. USACE Sacramento O&M Manual 519, June 1962 (HLM 6.34)] FS Date: 6/16/2017 1:51:41 PM

Overview of levee crown at crossing looking downstream.

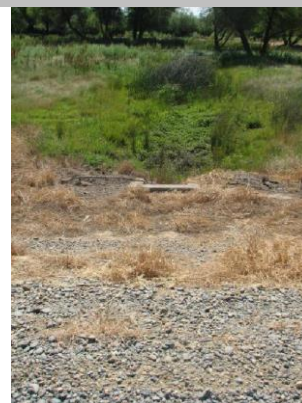
Photo 2 of 3 : UCIP_FA_2018_52203_66806.jpg

Comment Code						
Inspector Comment						
FS_ID:52203 DS_ID:16361 EP_NO: N/A Repair Type: Non-Urgent Crossing Status: Found UCIP Comments: 6/14/2017 WS appears to be in good condition. LS slide gate is buried and submerged. Pipe has been selected to be internally cleaned and inspected as part of the DMP project. (DWR Sutter Yard- AFreitag)11/16/2016 LS screwgate is buried and non-operational. (DWR Sutter Yard- AFreitag)4/28/2016 LS screwgate is still completely buried. 7/13/2015 LS screw gate is completely buried.5/21/2014 Same as last inspection.7/15/2013 WS slope has been cleared of vegetation and is in good condition. LS screw gate is still buried.12/2/2013 Same as last inspection.4/18/2012 LS slide gate is buried. Pipe is not visible on LS toe. Limited inspection on WS slope due to dense vegetation. FIELD_STRUCT_DESC: 24-inch corrugated metal drainage pipe through the levee, 7.4 feet below the crown. Flap gate on the waterside (WS) end. Slide gate on the landside (LS) end. Concrete "U" headwalls on both ends. [Additional Reference(s): DWR Levee Log, 1993. USACE Sacramento O&M Manual 519, June 1962 (HLM 6.34)] FS Date: 6/16/2017 1:51:41 PM

View of WS slope and toe.

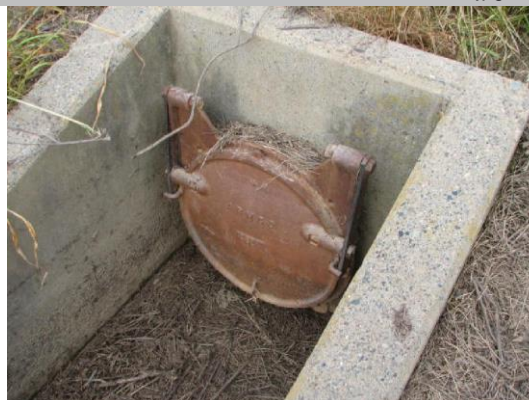
Photo 3 of 3 : UCIP_FA_2018_52203_66804.jpg

View of WS flap gate.

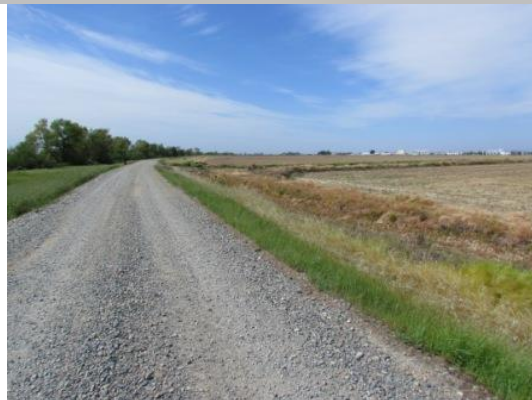
Photo 1 of 1 : FA_2018_MA0013_300_3_20180905_00001.jpg

LM Start	6.41	Rating **	M	Issue No.	3
LM End	6.99	Issue Type +	En	Location *	LS
Category	Earthen Levee			GPS Latitude/Longitude	
				Start	End
Item	Encroachments			39.508928 °	39.501438 °
				-121.714842 °	-121.719715 °
DWR ID	DWR_MA0013_01_s_2012_3				
Comment Code					
DT : Ditch					
Inspector Comment

View of the agricultural ditch along the toe.

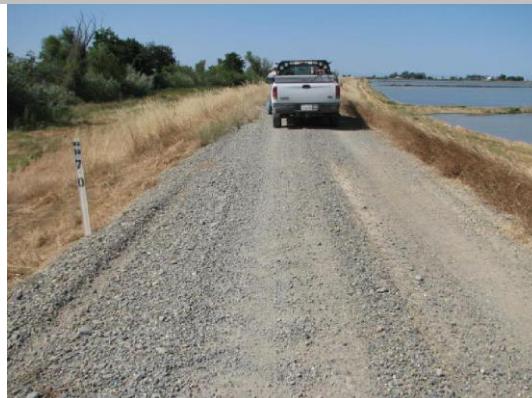
Photo 1 of 3 : UCIP_FA_2018_52211_66833.jpg

FS_ID:52211
DS_ID:16329
EP_NO: N/A
Repair Type: Non-Urgent
Crossing Status: Found
UCIP Comments: 6/14/2017 LS slide gate is still damaged and needing to be replaced. WS appeared to be in good condition. Pipe has been selected to be internally cleaned and inspected as part of the DMP project. (DWR Sutter Yard- AFreitag)11/16/2016 Needs a new screw gate installed on the LS. (DWR Sutter Yard- AFreitag)4/28/2016 LS slide gate is still bent. Everything else with the crossing appeared ok.7/13/2015 LS screw gate needs to be replaced. Everything else with crossing seems to be in good condition.5/21/2014 Same as last inspection.12/2/2013 Same as last inspection.7/15/2013 Slopes have been cleared of vegetation and are in good condition. There were no apparent signs of settling. LS screw gate is still damaged.4/18/2012 LMA's inspection sheet of 2011 indicates settlement and visible corrosion. Damage/severe corrosion on screw gate where it bolts to headwall. No visible signs of settlement due to high vegetation cover. Limited inspection on WS and LS slopes due to dense vegetation. Need photos of cleared slopes for this crossing. FIELD_STRUCT_DESC: 24-inch corrugated metal drainage pipe through the levee, 9.8 feet below the crown. Flap gate on the waterside (WS) end. Slide gate on the landside (LS) end. Concrete headwall on both ends. [Additional Reference(s): DWR Levee Log, 1993. USACE Sacramento O&M Manual 519, June 1962 (HLM 7.10)]

Overview of levee crown at crossing looking D/S.

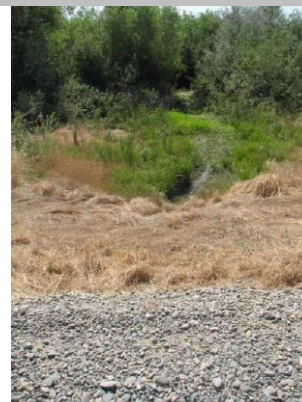
Photo 2 of 3 : UCIP_FA_2018_52211_66832.jpg

View of WS slope and toe.

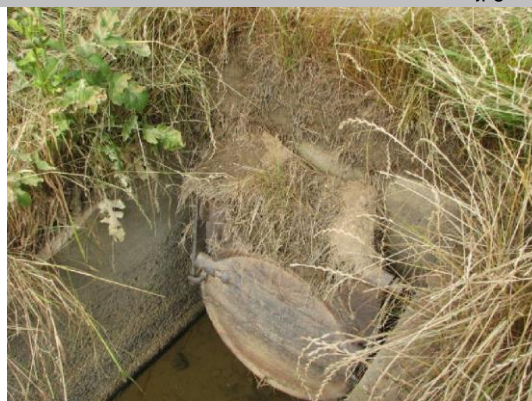
Photo 3 of 3 : UCIP_FA_2018_52211_66837.jpg

Comment Code						
Inspector Comment						
FS_ID:52211 DS_ID:16329 EP_NO: N/A Repair Type: Non-Urgent Crossing Status: Found UCIP Comments: 6/14/2017 LS slide gate is still damaged and needing to be replaced. WS appeared to be in good condition. Pipe has been selected to be internally cleaned and inspected as part of the DMP project. (DWR Sutter Yard- AFreitag)11/16/2016 Needs a new screw gate installed on the LS. (DWR Sutter Yard- AFreitag)4/28/2016 LS slide gate is still bent. Everyhting else with the crossing appeared ok.7/13/2015 LS screw gate needs to be replaced. Everything else with crossing seems to be in good condition.5/21/2014 Same as last inspection.12/2/2013 Same as last inspection.7/15/2013 Slopes have been cleared of vegetation and are in good condition. There were no apparent signs of settling. LS screw gate is still damaged.4/18/2012 LMA's inspection sheet of 2011 indicates settlement and visible corrosion. Damage/severe corrosion on screw gate where it bolts to headwall. No visible signs of settlement due to high vegetation cover. Limited inspection on WS and LS slopes due to dense vegetation. Need photos of cleared slopes for this crossing. FIELD_STRUCT_DESC: 24-inch corrugated metal drainage pipe through the levee, 9.8 feet below the crown. Flap gate on the waterside (WS) end. Slide gate on the landside (LS) end. Concrete headwall on both ends. [Additional Reference(s): DWR Levee Log, 1993. USACE Sacramento O&M Manual 519, June 1962 (HLM 7.10)] FS Date: 6/19/2017 10:17:38 AM

WS Flap Gate

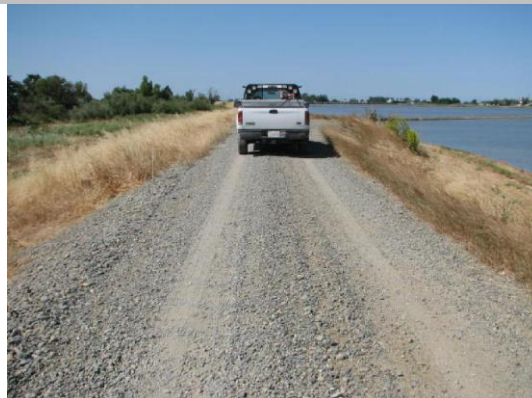
Photo 1 of 3 : UCIP_FA_2018_52212_66844.jpg

FS_ID:52212
DS_ID:16354
EP_NO: N/A
Repair Type: Non-Urgent
Crossing Status: Found
UCIP Comments: 6/14/2017 LS slide gate stem still bent. WS appeared to be in good condition. Pipe has been selected to be internally cleaned and inspected as part of the DMP project. (DWR Sutter Yard- A Freitag)11/16/2016 Screw gate stem bent but gate is still operational. (DWR Sutter Yard- A Freitag)4/28/2106 Tested positive closure device the bent stem on the slide gate did not seem to affect its functions. Gate operable.7/13/2015 LS screw gate stem is still bent. Gate should still be able to close fully. The rest of the crossing seems to be in good condition.5/21/2014 Same as last inspection.12/2/2013 Same as last inspection.7/15/2013 Slopes have been cleared of vegetation and are in good condition. LS screw gate stem is still bent.4/18/2012 LS slide gate stem is bent and needs to be replaced. Limited inspection on WS and LS slope due to dense vegetation. Need photos of cleared slopes during next inspection. Confirmed flap gate on WS. This crossing was listed in the USACE Periodic Inspection report as Corp's inspect ID#USACE_CESPK_M13D_2011_p_0244 for submerged WS gate. FIELD_STRUCT_DESC: 24-inch corrugated metal drainage pipe through the levee, 11.2 feet below the crown. Flap gate on the waterside (WS) end. Slide gate on the landside (LS) end. Concrete "U" headwall on both ends. [Additional Reference(s): DWR Levee Log, 1993. USACE Sacramento O&M Manual 519, June 1962 (HLM 7.34)]

Overview of levee crown at crossing looking D/S.

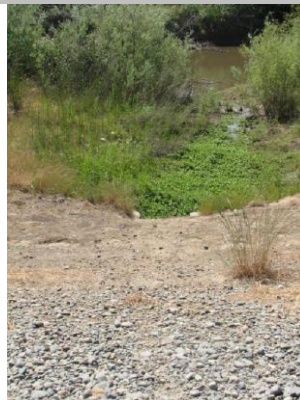
Photo 2 of 3 : UCIP_FA_2018_52212_66845.jpg

Comment Code						
Inspector Comment						
FS_ID:52212 DS_ID:16354 EP_NO: N/A Repair Type: Non-Urgent Crossing Status: Found UCIP Comments: 6/14/2017 LS slide gate stem still bent. WS appeared to be in good condition. Pipe has been selected to be internally cleaned and inspected as part of the DMP project. (DWR Sutter Yard- A Freitag)11/16/2016 Screw gate stem bent but gate is still operational. (DWR Sutter Yard- A Freitag)4/28/2106 Tested positive closure device the bent stem on the slide gate did not seem to affect its functions. Gate operable.7/13/2015 LS screw gate stem is still bent. Gate should still be able to close fully. The rest of the crossing seems to be in good condition.5/21/2014 Same as last inspection.12/2/2013 Same as last inspection.7/15/2013 Slopes have been cleared of vegetation and are in good condition. LS screw gate stem is still bent.4/18/2012 LS slide gate stem is bent and needs to be replaced. Limited inspection on WS and LS slope due to dense vegetation. Need photos of cleared slopes during next inspection. Confirmed flap gate on WS. This crossing was listed in the USACE Periodic Inspection report as Corp's inspect ID#USACE_CESPK_M13D_2011_p_0244 for submerged WS gate. FIELD_STRUCT_DESC: 24-inch corrugated metal drainage pipe through the levee, 11.2 feet below the crown. Flap gate on the waterside (WS) end. Slide gate on the landside (LS) end. Concrete "U" headwall on both ends. [Additional Reference(s): DWR Levee Log, 1993. USACE Sacramento O&M Manual 519, June 1962 (HLM 7.34)] FS Date: 6/19/2017 10:19:12 AM

View of WS slope and toe.
